Manhole Inspection Summary

Manhole # S47CC_006MH

Location Address: **2202 Ashland Ave.** Cross Street: **N. Collington Ave.**

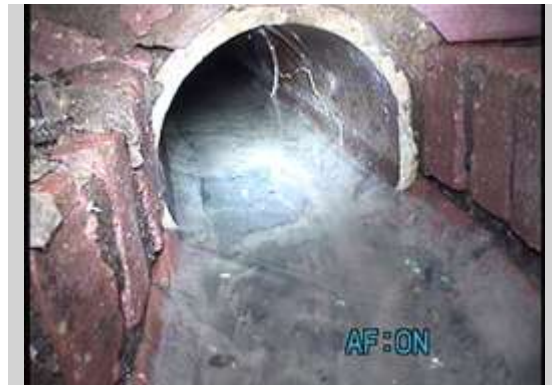
Pipe In @ 3 O'Clock

Pipe Height: **12** (in.) Rod and Bar (Angled)
Pipe Material: **Clay** ☐ Pipe Lined
Invert Depth: **8.67** (ft.) Flow Characteristics: **Slow**
Deposits: ☒ None ☐ Mud ☐ Sludge ☐ Debris ☐ Grease
Silt Depth: (in.) Deposits Extent:
Infiltration: **None** Pipe Seal Cond: **Sound**
